Report 500-87.25

FEB 9 1987
PACIFIC GAS AND ELECTRIC COMPANY
DEPARTMENT OF ENGINEERING RESEARCH
3400 Crow Canyon Road
San Ramon, California 94583

LABORATORY TEST REPORT

SUBJECT: EVALUATION OF J-HOOKS AND EYES FROM 115KV OLEUM G-LINE

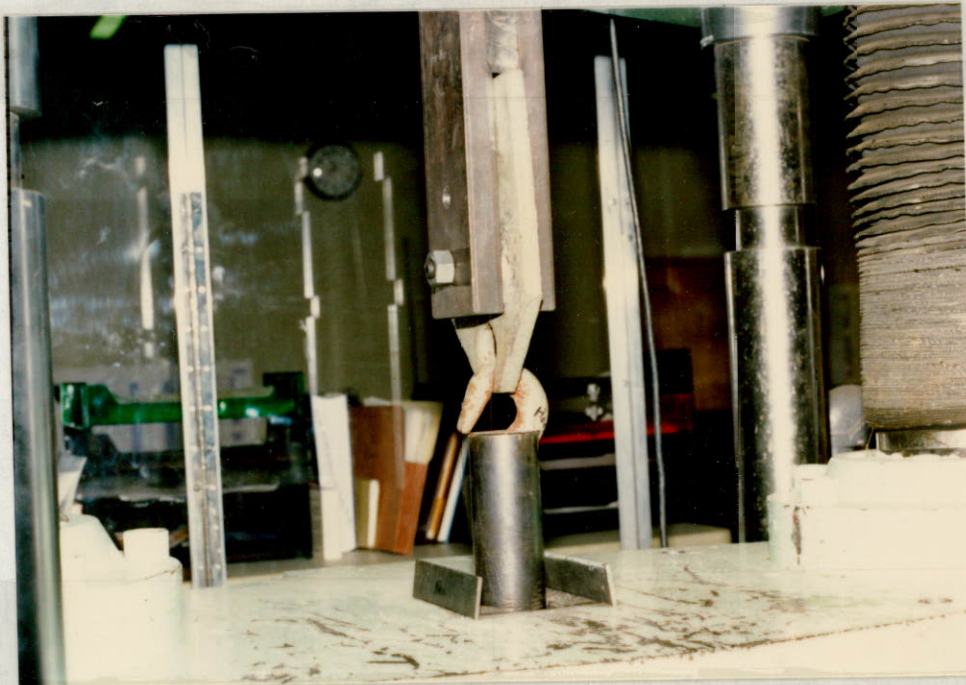
Figure 3. This shows the fixture holding the plate and J-Hook in the simulated position it would be in service.

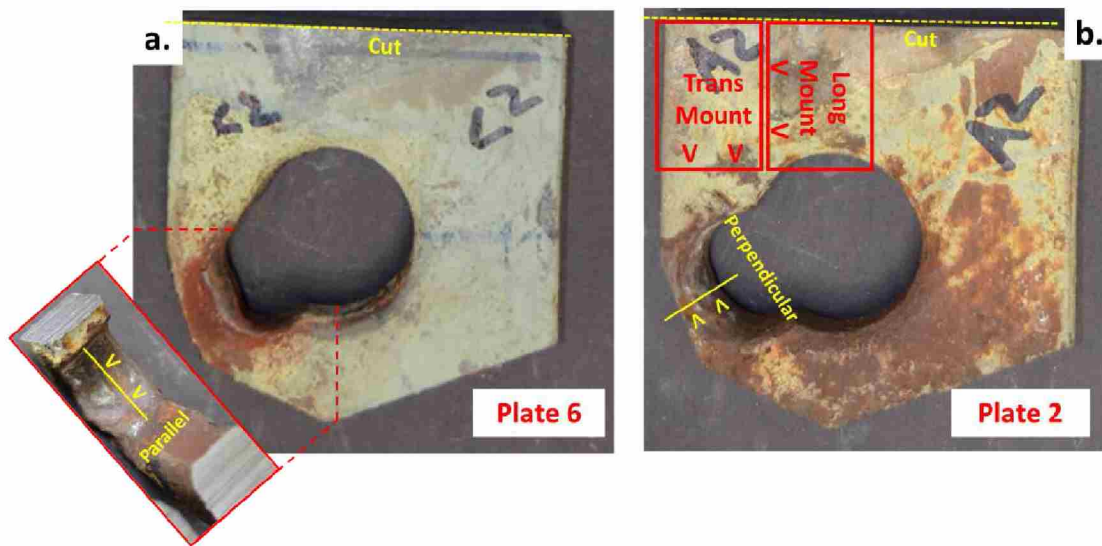
Fig. 7 shows the cut-map describing the locations from which sub-samples were taken for metallographic inspection. Transverse and longitudinal samples of the bulk microstructure were obtained from the locations indicated in Fig. 7b. These mounts are transverse to, and parallel to, the long-axis of the plate, respectively. Also, the microstructure beneath the wear surfaces was sampled parallel to the wear surface (Plate 6, Fig. 7a), and perpendicular to the wear surface (Plate 2, Fig. 7b).

Figure 7: Cut-map showing the locations from which the metallographic sections were taken.

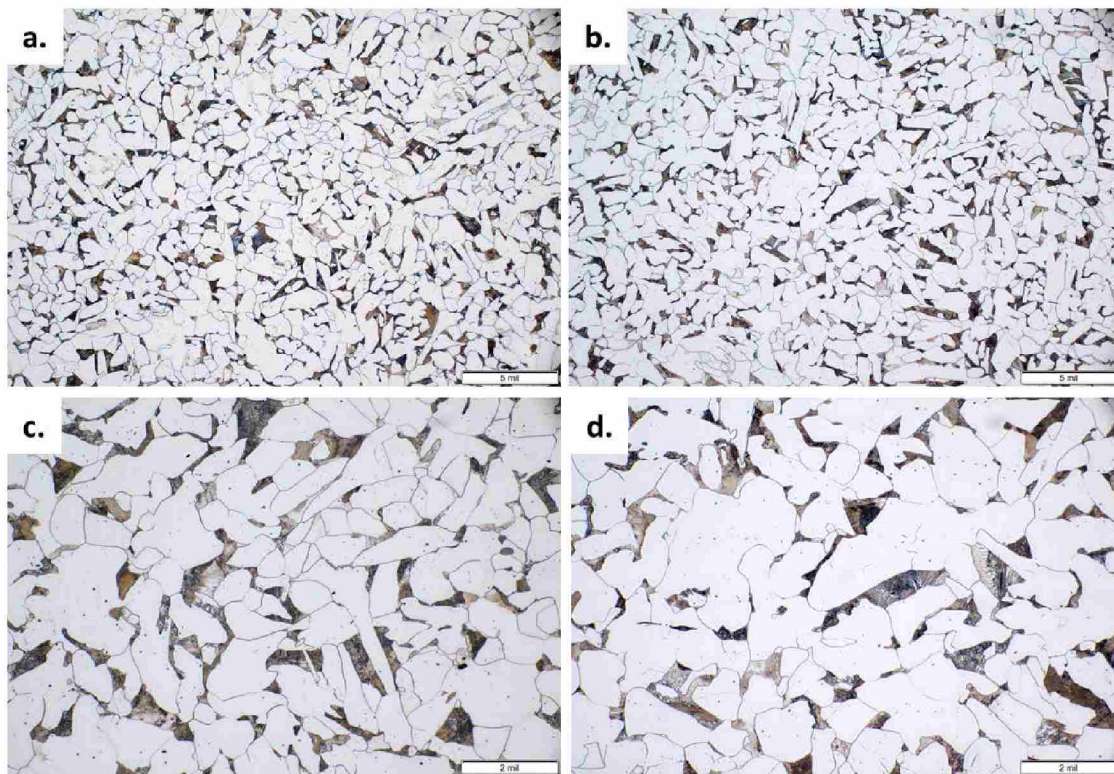
Fig. 8 shows the bulk microstructure from Plate 2 at 200x and 500x. The microstructure is comprised of dark pearlite regions in a light ferrite matrix, and is consistent with published examples of low carbon steel, e.g., grade ASTM A36.² The ferrite is generally polygonal (equiaxed) in both the transverse (a, c) and longitudinal (b, d) microstructures, indicating full recrystallization and little or no residual deformation (banding) from the manufacturing or rolling processes.

Figure 8: Metallographic cross-sections at 200x (top) and 500x (bottom), etched to reveal the microstructure. The sections were taken from the locations indicated in Fig. 7b: (a, c) 'Trans Mount', and (b, d) 'Long Mount'. The microstructures are imaged along the directions indicated by the red V's in Fig. 7b.
